CERTIFICATE OF APPROPRIATENESS

Property: 623 Highland Street, Lot 11, Tract 10, Block 30, Woodland Heights Subdivision. The property includes a historic 2,135 square foot, one-story wood frame single-family residence and detached garage situated on a 7,500 square foot (75' x 100') interior lot.

Significance: Contributing Center Hall Victorian Cottage residence, constructed circa 1900, located in the Woodland Heights Historic District.

Proposal: Alteration – The applicant was denied a COA by the Commission at the February 13, 2014 HAHC meeting, to replace 17 original 1-over-1 wood sash windows with 17 new composite sash windows. The applicant has resubmitted the application to replace 17 original 1-over-1 wood sash windows with 17 new 1-over-1 composite sash windows within the same openings.

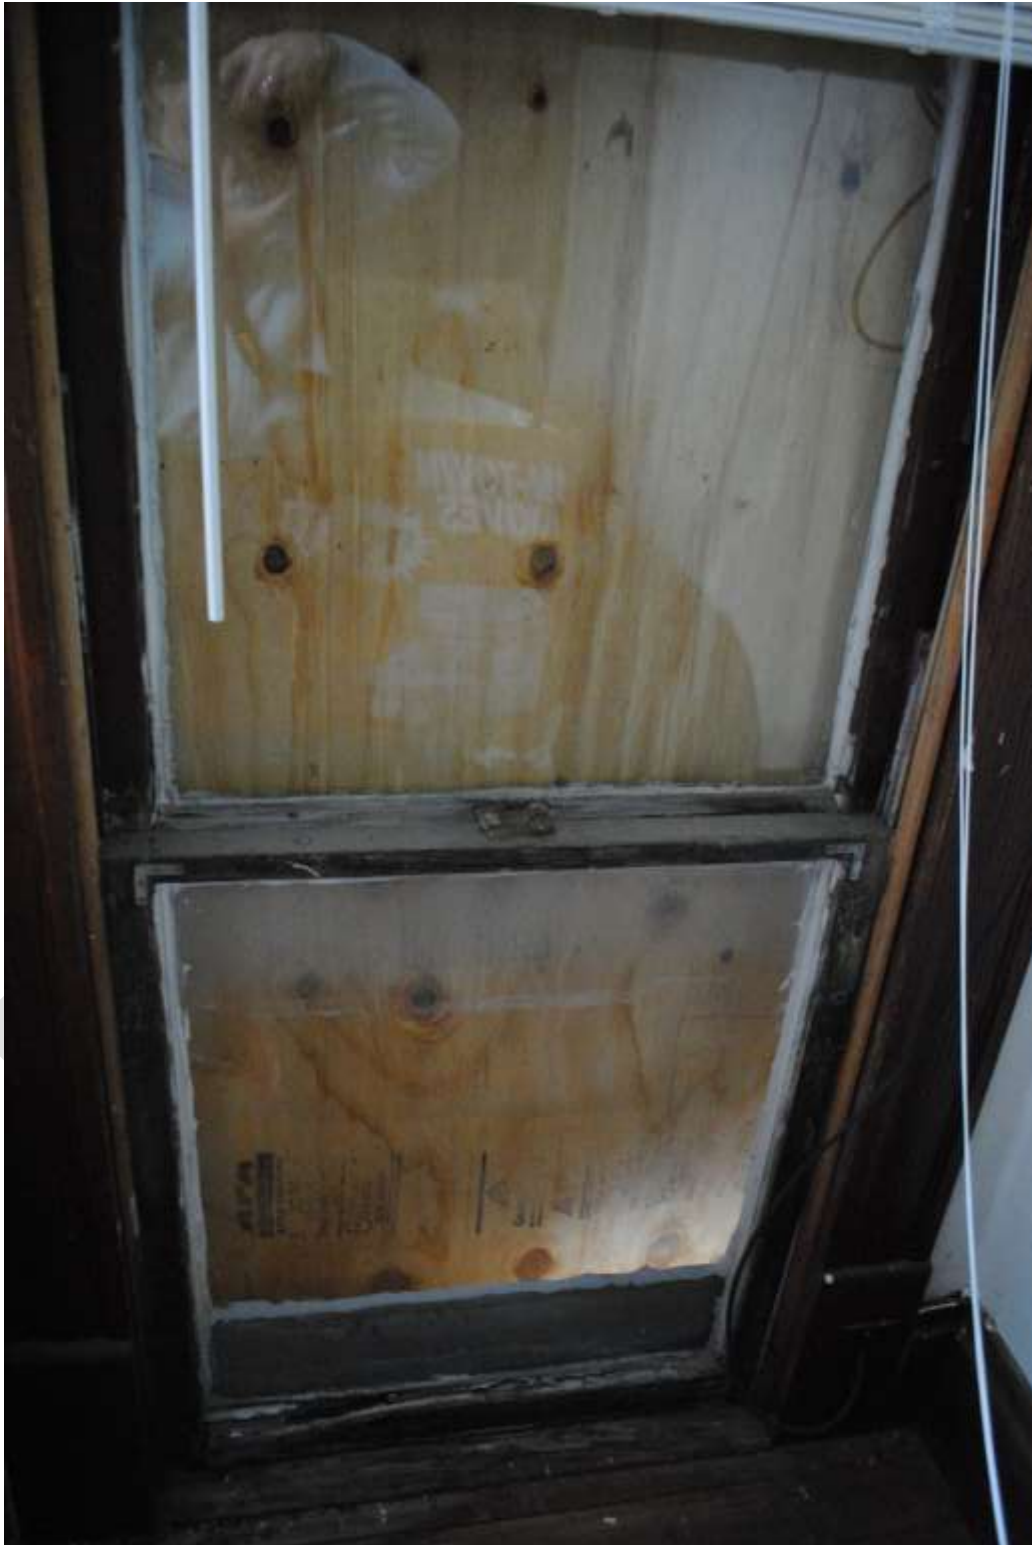
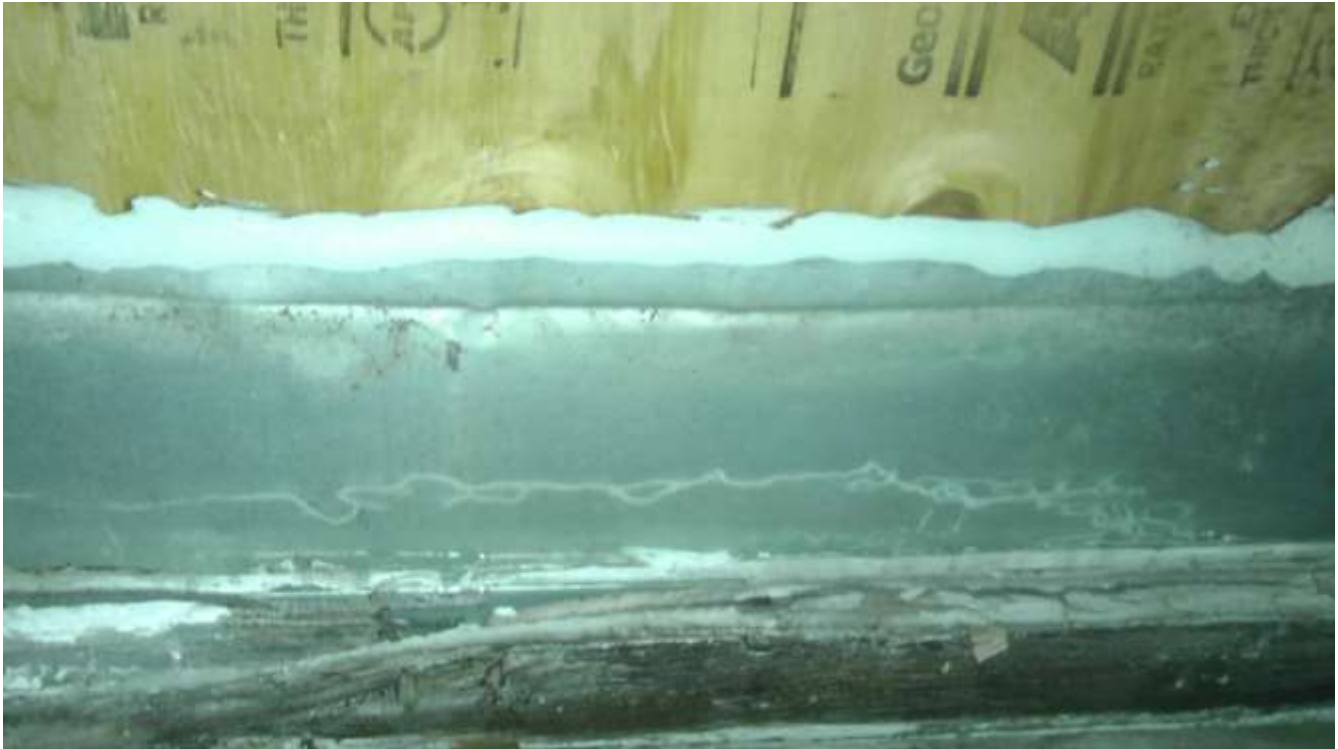
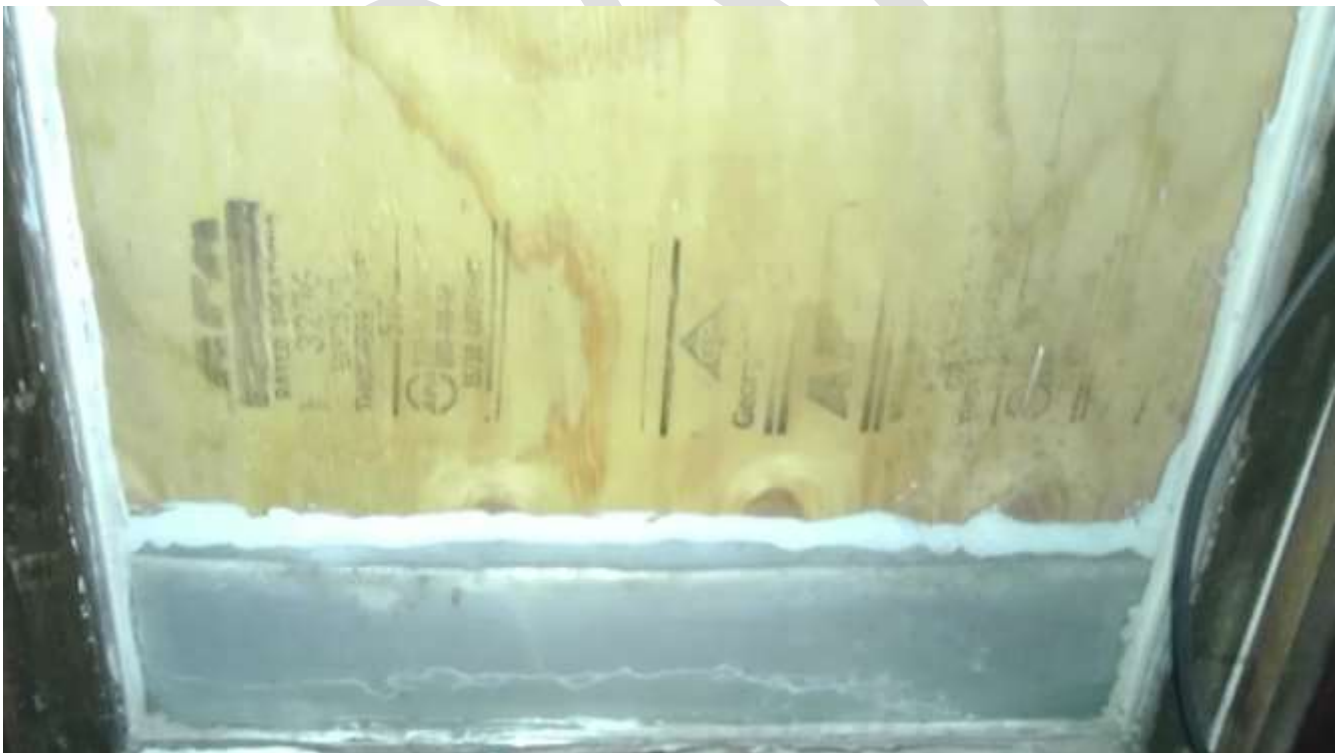
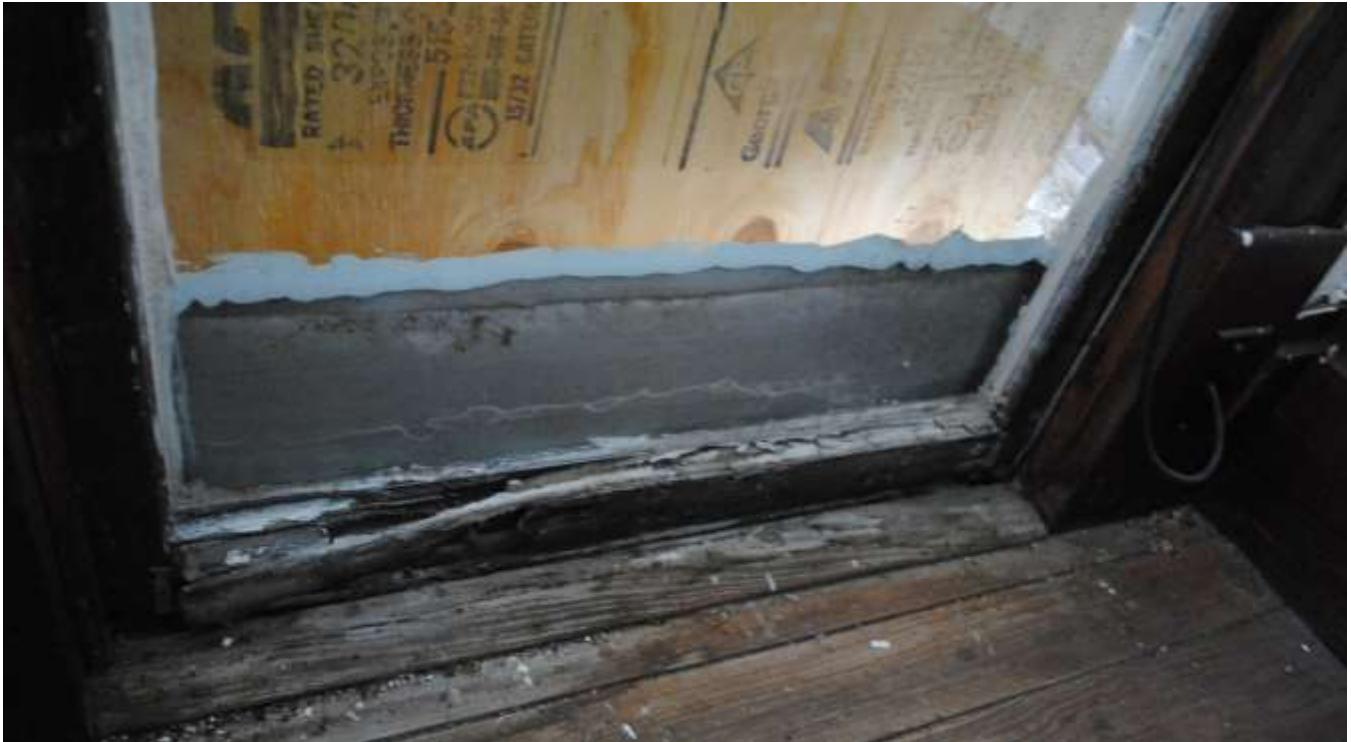
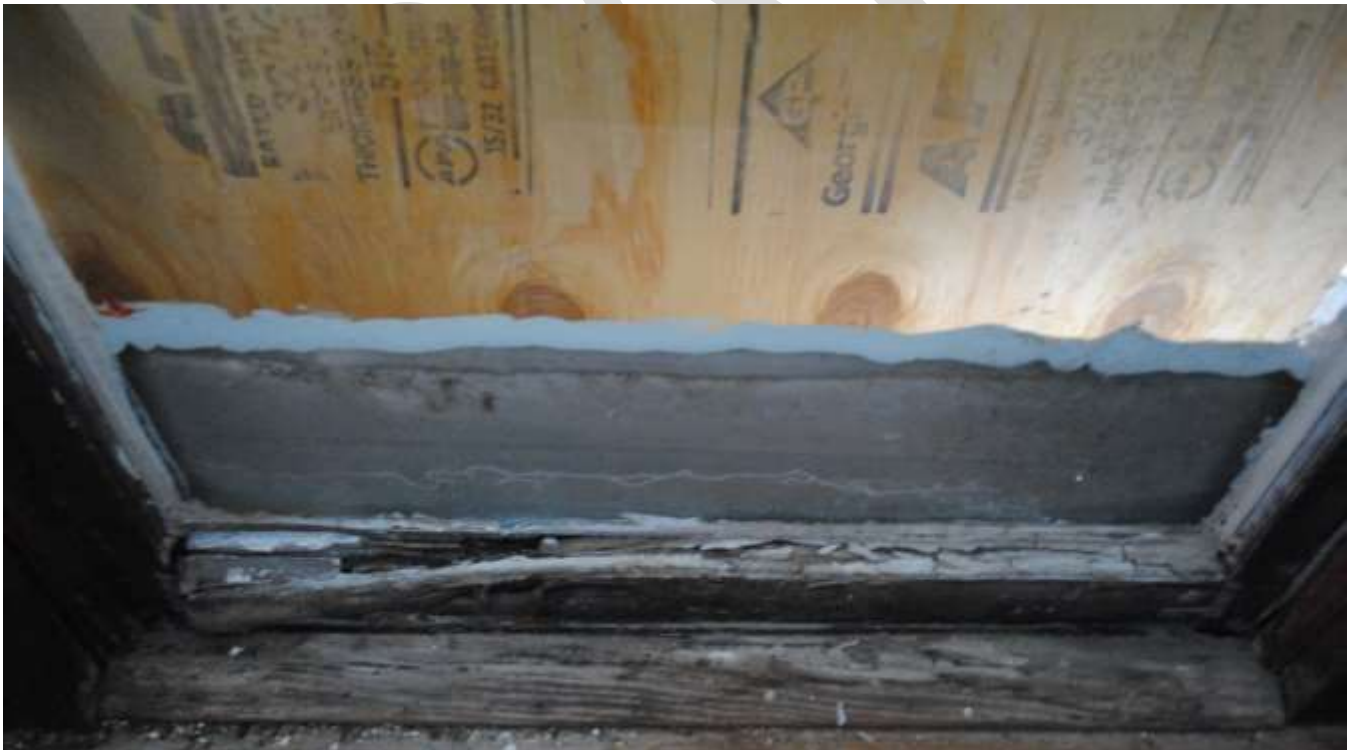
Window 222

Window 117 has a sagging meeting rail and window 222 shows signs of rot on the bottom sash.

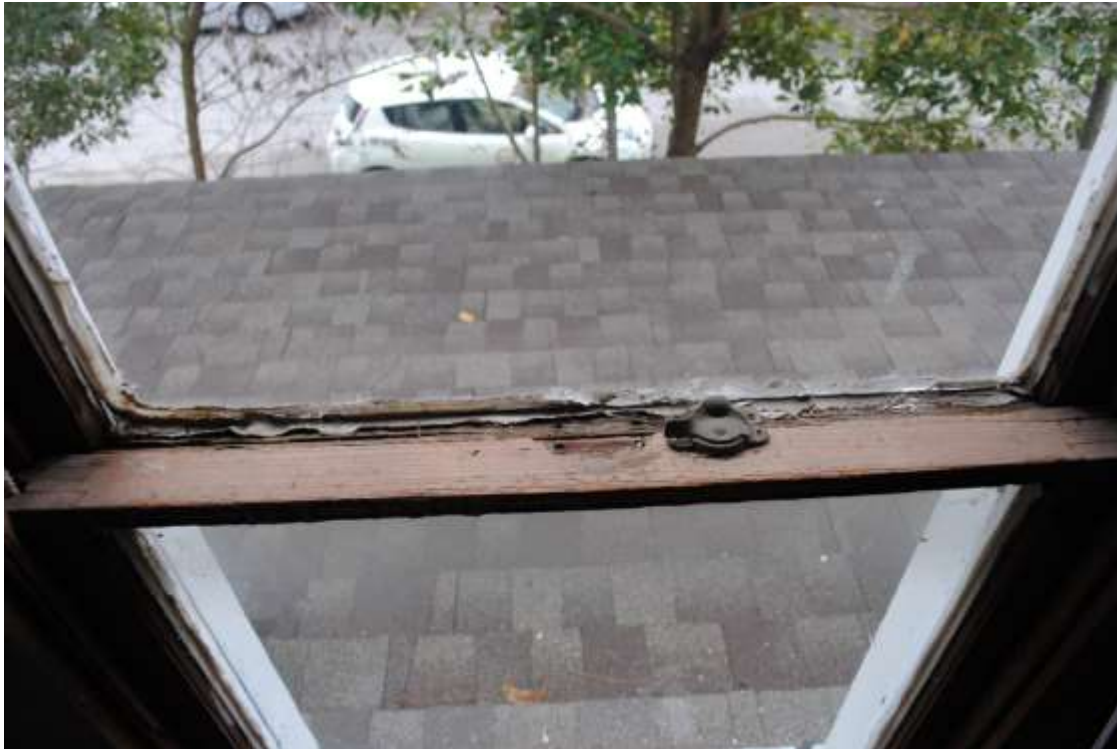
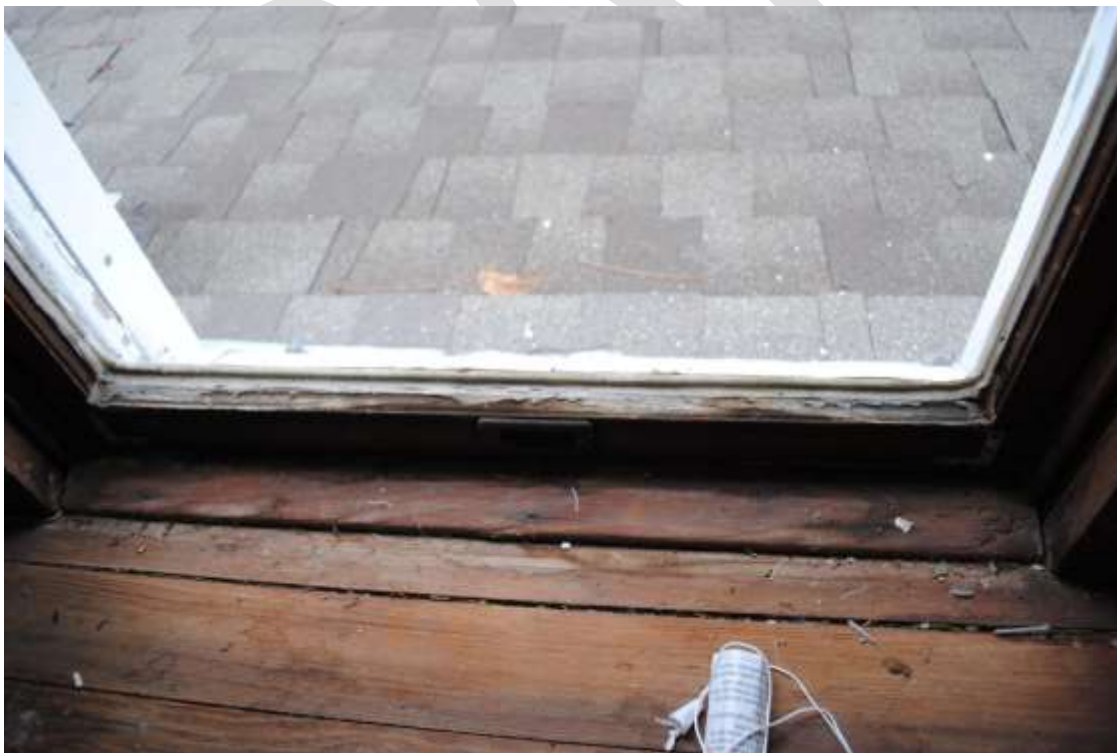
Window 223

Unit # 223 Attic Bedroom – Sash are rotted, lead paint is peeling. Damaged beyond repair, Window does not open and Window glass is broken and has plywood in the place of glass. Water has intruded causing massive damage to the original hardwood attic floor and potentially the floor joist.
